ABOVE GROUND LEVEL <sup>TM</sup>

AUG/SEPT 2008

# Copper Theft: Problem, Testing, Solution

AT&T partnered with security company SNC in an effort to halt the theft of copper from the wireless carrier's cell sites in its North Texas operating area.

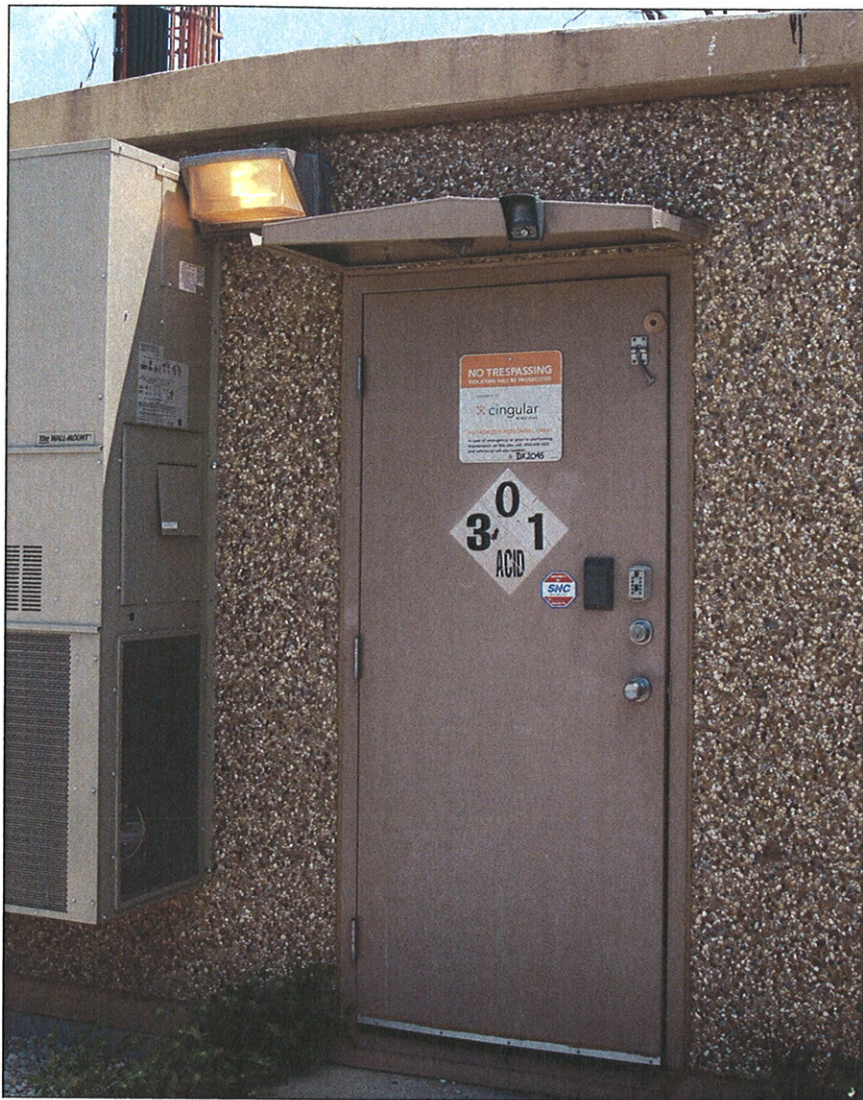
**This view of a shelter shows the camera above the door and a proximity card reader on the door above the doorknob. The camera also views any approach to the air conditioner. Some thieves have removed air conditioners to gain entry to the building and have stolen all or part of the air conditioners for the metal they contain.**
